# The Sewerage & Water Board of New Orleans Non-Invasively Locates Massive Leak, Reduces Non-Revenue Water

The Sewerage & Water Board of New Orleans (SWBNO)

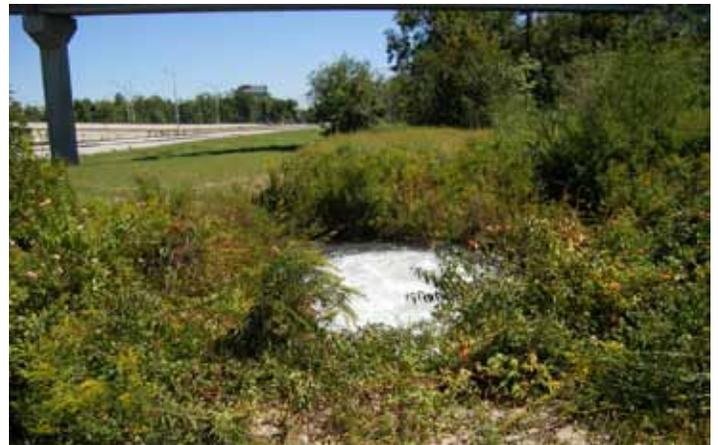
Echologics engineers non-invasively pinpointed the leak, which was a blown-off hydrant lead that was flowing into a nearby drainage ditch. Analysis showed that the leak had been losing at least 7,200,000 gallons of water per day.

Echologics' non-invasive investigation revealed the problem; a massive leak was pinpointed on a span of 20" inch AC pipe. The leak was located in a remote area that was close to a road embankment, but the engineers quickly discovered that this was no ordinary leak—it was a blown-off hydrant lead that was connected to the transmission main. Water was flowing out of the leak into a nearby drainage ditch.

SWBNO crews immediately repaired the leak and flow rates returned to normal levels. Echologics compared historical flow data to data that was collected after the leak was repaired; the analysis concluded that the transmission main, which regularly flowed at 450,000 gallons of water per hour, had been losing at least 7,200,000 gallons of water per day through the massive leak.
